MANUAL SWING BARRIER GATE INJURIES

By Michael Panish, Door & Gate Expert Witness

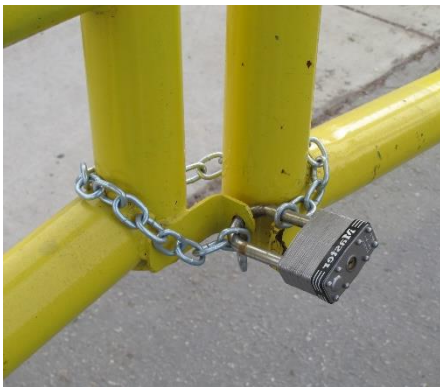
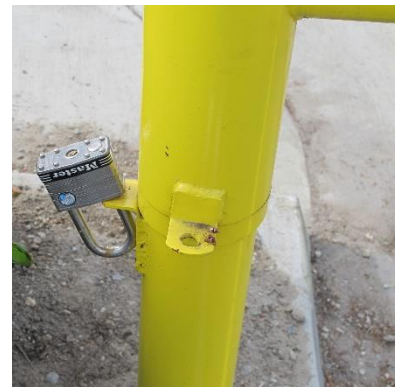
Below are a few example photos showing types of restraints that are considered industry accepted devices to positively lock the position of swinging barrier arms.

There are many methods that can be used to secure barrier arms so that they remain in an intended fixed position. Most of these methods are inexpensive to install or retrofit. Maintenance and observation by the owner or management of the property where these manual barrier arms are installed is essential to ensure the safety of the general public.
