AUTOMATIC ENTRY GATES

PERSONAL INJURY & DAMAGE CLAIMS

By Michael Panish
Door & Gate Expert Witness

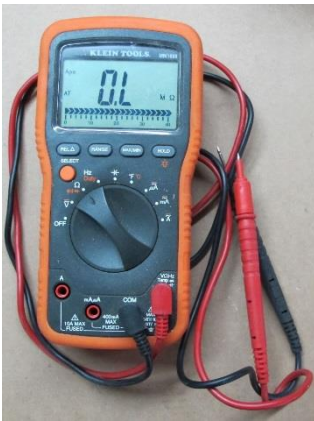
The multi-meter (left) has a resistance setting to measure ohms. This is a typical type of (megohm) measuring device capable of applying voltage to an in-ground loop.

This view of the electronics in a typical gate operator (right) shows three installed modules that are attached to the in-ground loops.

In-ground loops require routine analysis for continuity and condition. Damage due to corrosion by chemical reaction of the insulation of the wire loop and roadbed material can create changes in the activation fields of these magnetic devices or cause them to fail completely. Sometimes, weather conditions are also responsible for improperly working sensor loops. Temperature, snow, ice, and water can lead to defective operation of a deferred control wire loop that has lost insulation qualities. These loops need to be checked using a specific piece of equipment referred to as a “meg” meter that is designed to measure the magnetic inductance. A competent service provider must use this “megohm” resistance measuring equipment and understand what the readings mean. Generally, low or inconsistent readings indicate that the loop must be replaced. Mid-range readings usually indicate a working loop. There are various ranges on the meters which are used to verify the overall loop responses which are chosen depending upon the size, length, and gauge of wire installed in the ground.

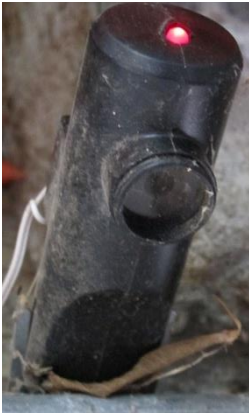
One of many styles of optical sensors available (left), added as additional safety for some gate installations.

In addition to the various activation products, there are many different kinds of ancillary safety products manufactured and readily available for automatic gate controllers. At times, wrongfully considered as an optional piece of equipment, these products provide functions designed to protect users from inadvertent gate operations and adverse forces that can be potentially imparted to the gate via the motor control mechanism.

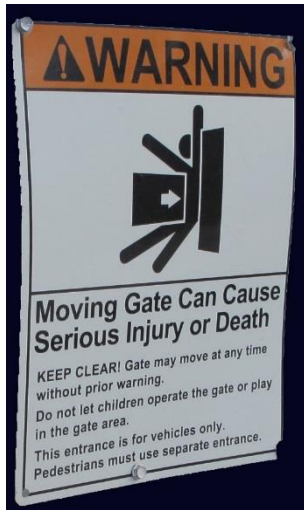
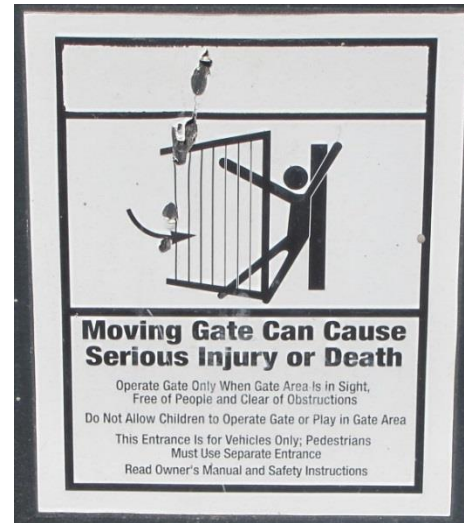
Two versions of manufactured supplied warning placards. There are a variety of types of styles furnished by different manufacturers, but the information is fairly consistent “the gate can move at any time without warning; do not let children play on or around the gate and motor equipment; the gate motor control is designed to allow vehicular access, not for pedestrian access; read and understand the operating and owner’s manuals”

Manufacturer designed signage that usually accompanies the gate motor controller is often not enough to inform users of the real potential dangers. That does not make the manufacturers responsible for gate and motor controller injuries in any way. Warning signs provided by the manufacturer are the final attempt by the manufacturer to inform the general public that there are inherent, and generally reasonable acceptable known operating dangers associated with their products operation.

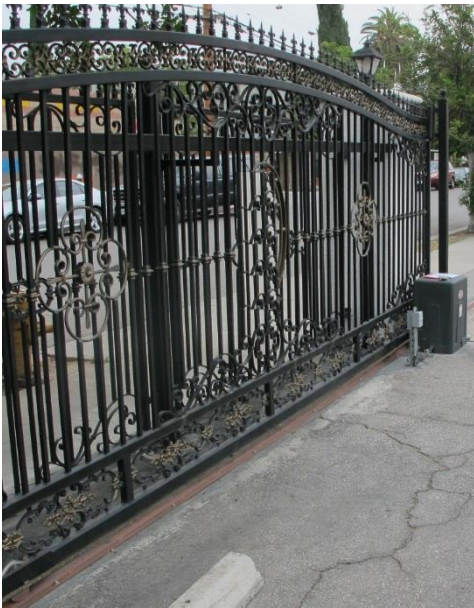
A typical highly ornamented sliding wrought iron gate system. This gate is operated by a chain driven operator.

Note: the bronze cover of the gate operator and the gray colored disconnect switch in the lower right hand corner of this picture.

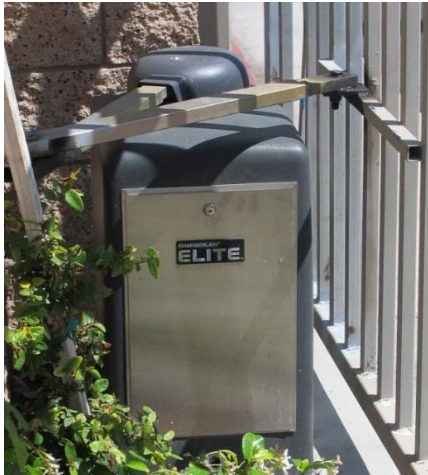
Two examples of a gate operator that is directly coupled to a swinging gate. Note: the arm and elbow that folds and extends as the gate is opened and closed. This arm operation can be dangerous to a worker or pedestrian and cannot be completely enclosed due to the operational requirements of the motor control mechanism.

Note: the manufacturer supplied white label on the operator cover warning anyone in proximity of the dangers associated with this device.

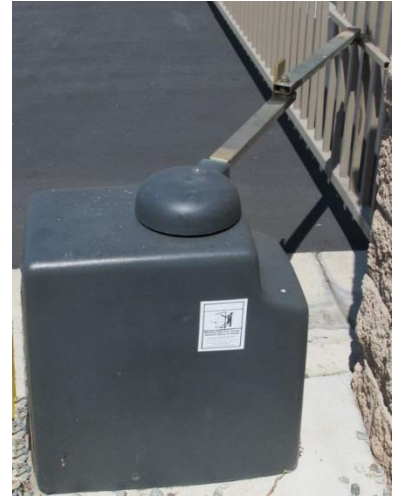
Swinging gates that have arms attached between the motor controller and gate are an example of a directly coupled mechanical system. Often these type of motor controllers utilize a revolving control shaft that has an arm connected to transfer the power of the operator in a linear fashion. Due to the necessity of installation, elbow like joints attached to control arms are needed to allow movement of the gate. Pinch points and crush zones are common as a result of the mechanical movement of these products. Warning labels positioned on the controller housings alert workmen and the general public in proximity that a potentially hazardous condition can occur. It is essential that anyone approaching the gate and operator be aware of the immediate potential for operation without any warning. Failure of workers to take appropriate precautions and “lock-out” or turn off the operator has resulted in severe injuries and death claims. Failure to heed the applied warning labels have resulted in a variety of injury claims by the general public, including death.

It is almost impossible to safeguard these automatic devices beyond warning labels as movements of the arms and motor controller must happen to operate the gate. Strong resistive movements are needed and expected to motivate the gate operation. There are no safety devices designed to counteract forces of the primary gate controller as no personnel should be lodged within the path of travel of the operator mechanism at any time. I have never seen an installation where it has been possible to completely enclose all of the components of the gate and operating arm to protect a person from harm that was within the zone of operation. No matter how ingeniously designed the installation, there are still required areas of movement of the motor controlled equipment that can potentially entrap, entangle or crush an unauthorized access of an individual.

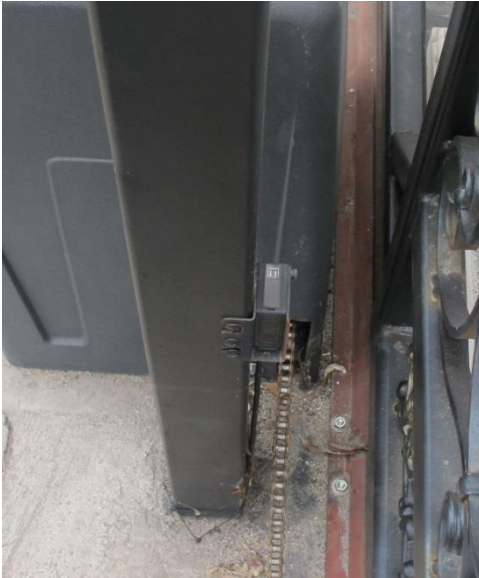
This photo shows a chain driven gate. The chain in this device either passes over a driven pinion gear or coils and uncoils as the gate travels. Note: the small bracketed device directly above the chain on the pole. This is one example of a cross threshold beam emitter designed to safeguard the threshold of the gate.

In general, chain driven equipment is usually installed on sliding gate systems. There are at least two different methods used to convey the gate. In the first system, a small gear rotates engaging the links of the chain. This gear moves the chain back and forth without capturing the links. The chain remains attached to the full width of the sliding gate and is permanently anchored at both ends of the gate.
