DEFECTIVE GATE DESIGNS CAN CAUSE PERSONAL INJURY & WRONGFUL DEATH

By Michael Panish, Gate Expert Witness

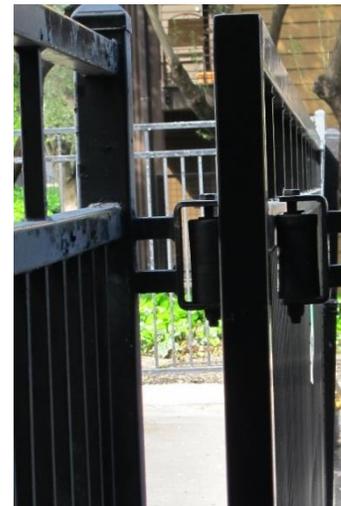
An example of a gate improperly fabricated with no perpendicular stop installed at the top that allowed the gate to travel past the desired stop and fall. →

Most of the injury claims that involve sliding gates falling onto pedestrians are the direct result of an original failure to install adequate restrictors or, through lack of inspection and maintenance, original components are bent out of alignment, broken, or completely missing. The design intent and the purpose of perpendicular intersecting metal stops are to keep the sliding mechanism from exceeding the upright enclosure. I have seen installations where there are no upright corrals that need to be in place to maintain the sliding gate in an upright and secure position. When gate stops are broken or missing, the full length of the gate can be pulled past the fixed corral that is supposed to keep the gate in an attached and upright position when the gate has over-traveled.

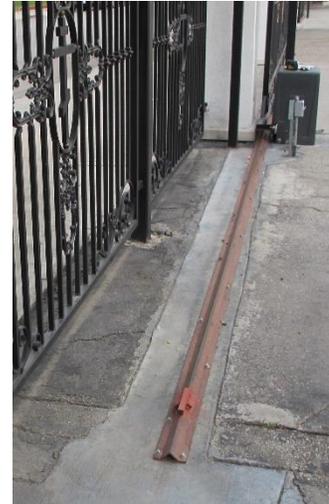
Typical surface mounted V-Track

Another common defect that leads to serious gate injuries are the methods that convey the gate. There are at least a couple of common installations that rely upon rolling wheels to direct and attach the gate to the fixed fence portion of the enclosure. One typical type of rolling installation utilizes an inverted V-shaped steel track that is implanted under the path of the sliding gate.

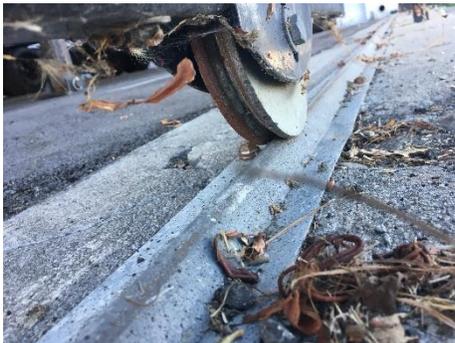
**Sliding gate wheel with mating grooved slot to follow V-Track. Note adjacent debris which can cause derailment.**

On the leading and trailing edges of the moving gate, the bottom corners of the gate have a mating V-shaped roller that rides upon the inverted track.

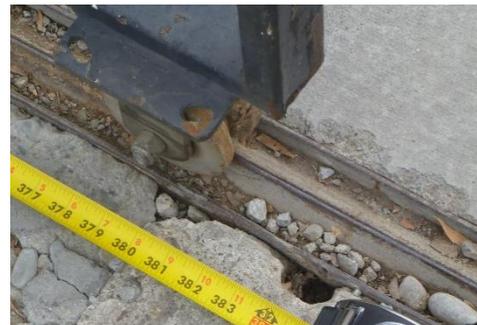
In ground recessed V-Track with rocks & pebble debris that caused front wheel to derail.

In most installations the rollers are steel or aluminum. I have also observed nylon or plastic rollers. With any V-track installation there are a few ongoing maintenance issues that need to be followed. The roller must be checked for function, lubrication, and attachment. There is usually an axle that is centered on the hub of the roller wheel that runs through some sort of bearing. If the bearing wears through usage or abuse, the axle often is no longer centered or concentric, and the wheel will not travel smoothly and consistently. If there is no bearing and only a hole in the center of the guide wheel, the hole can become ovalized and the axle will not maintain true alignment, causing the wheels to hump or bind as the gate is moved open and closed, often falling off of the V-track. Further maintenance is required for an above ground V-track installation. The track must be

checked for full attachment to the pavement where it is positioned. Whether it is recessed or surface mounted, the entire length of the track must be constantly checked for any materials that would cause a derailment. These obstructions can include rocks, pebbles, trash, or other debris that can affect the connection between the roller and track.

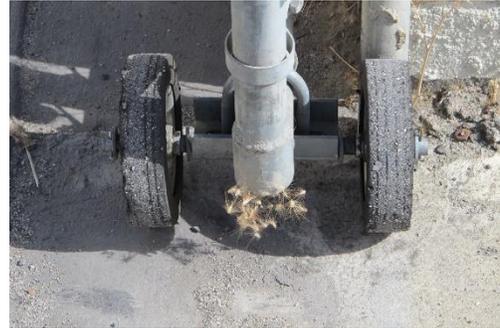
Multiple wheels attached to the sliding gate need to be routinely inspected for alignment, lubrication, and that they are in a stable fixed location so that the sliding gate does not bind or fall off of the horizontal railings. This type of conveyance system also requires a positive vertical corral and proper perpendicular stop to maintain the sliding gate in an upright position. Depending upon the weight and size of the sliding gate, the horizontal rail system is often augmented with a pair of rubber rolling wheels on the leading edge.

These rolling wheels take a portion of the sliding gate weight and need to be properly maintained for alignment so that the gate travels in a straight line.

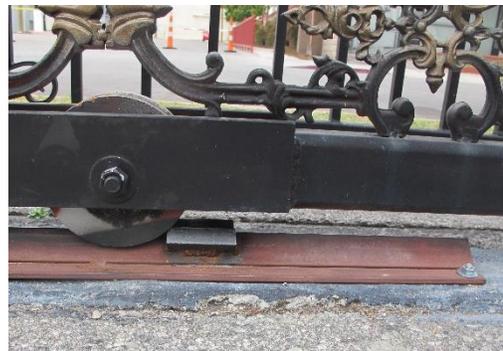
Many gate injuries have occurred when a service provider installs an automatic operator but fails to evaluate and recognize that the gate is improperly configured as a manual gate prior to their work. Gates are often missing required stops and properly designed vertical corrals. Ignorant or careless service providers automate the gate system without concern. They install the gate operator and create an extremely dangerous condition by relying upon the stop mechanism of the operator to control the movement limits of travel of the sliding gate. These limits are either electronic or manually adjusted to allow the gate to open and close without any protection from the missing fabricated perpendicular stops or vertical corrals.

Over the course of time, without appropriate inspections or maintenance, the sliding gate travel limits that were originally determined by the operator installer can drift electronically or mechanically break due to age, usage, or abuse. This allows the gate operator to continue to operate and move the sliding gate past the point where it is no longer attached to the fixed part of the fence. This often pushes or pulls the sliding gate into a location where it falls upon a pedestrian or vehicular user that is unaware of the defective condition of the gate.
