# MANUAL SWING BARRIER GATE INJURIES

*By Michael Panish, Door & Gate Expert Witness*

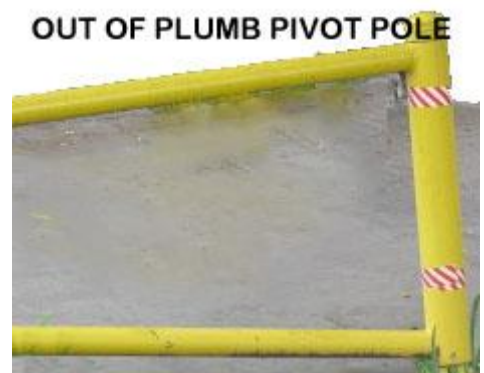
In some claims the pivot pole that mounts and grounds the barrier arm is out of plumb and gravity moves the unrestrained barrier arm out of a fully open position. Early American sailing ships often placed cabin door frames out of plumb to keep cabin doors closed without any mechanical devices. The deferred or damaged out of level pivot pole causes the gate arms to swing when unrestrained. The out of plumb pivot point acts much like the ships door frame that is inclined. This along with other forces causes barrier arms to move and not always in the desired fully open or fully closed direction. Lack of oversight and maintenance of many barrier arms can lead to dangerous conditions that have injured many people.

In general, the unsecured condition of these swinging gates has existed due to intentional abuse and vandalism, design and fabrication defects or deferred conditions due to lack of maintenance and repair.

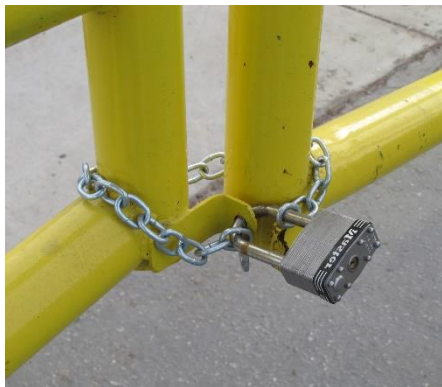
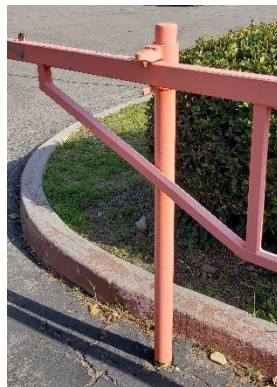
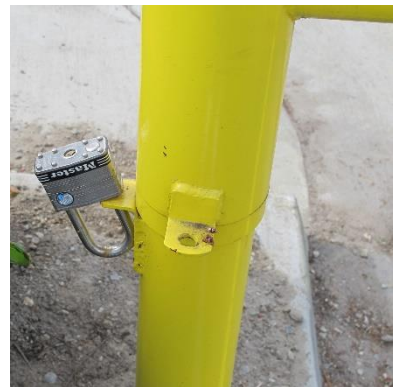
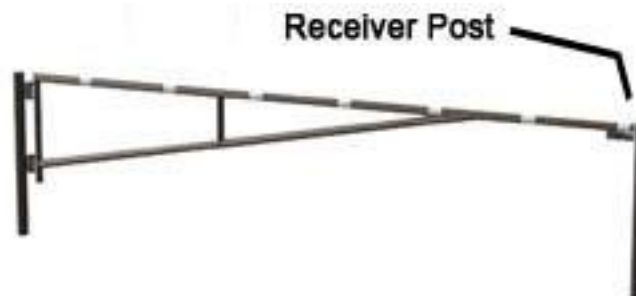
Below are a few example photos showing types of restraints that are considered industry accepted devices to positively lock the position of swinging barrier arms.

There are many methods that can be used to secure barrier arms so that they remain in an intended fixed position. Most of these methods are inexpensive to install or retrofit. Maintenance and observation by the owner or management of the property where these manual barrier arms are installed is essential to ensure the safety of the general public.
