# MANUAL SWING BARRIER GATE INJURIES

*By Michael Panish, Door & Gate Expert Witness*

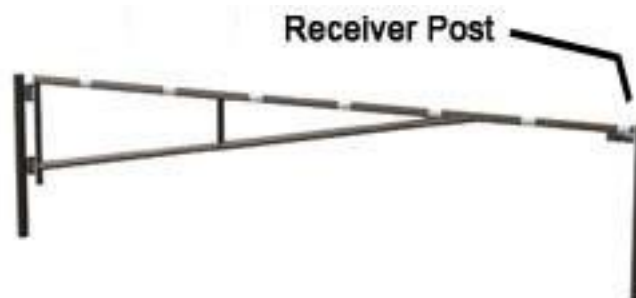
Below are a few example photos showing types of restraints that are considered industry accepted devices to positively lock the position of swinging barrier arms.

There are many methods that can be used to secure barrier arms so that they remain in an intended fixed position. Most of these methods are inexpensive to install or retrofit. Maintenance and observation by the owner or management of the property where these manual barrier arms are installed is essential to ensure the safety of the general public.
